# Retrofit Put to the Test

Testing shows where a building envelope retrofit succeeds and where opportunities remain.

By Brian H. Neely, AIA, NCARB, CDT, and Joshua T. Hogan, E.I.T., CDT, Gale Associates Inc.

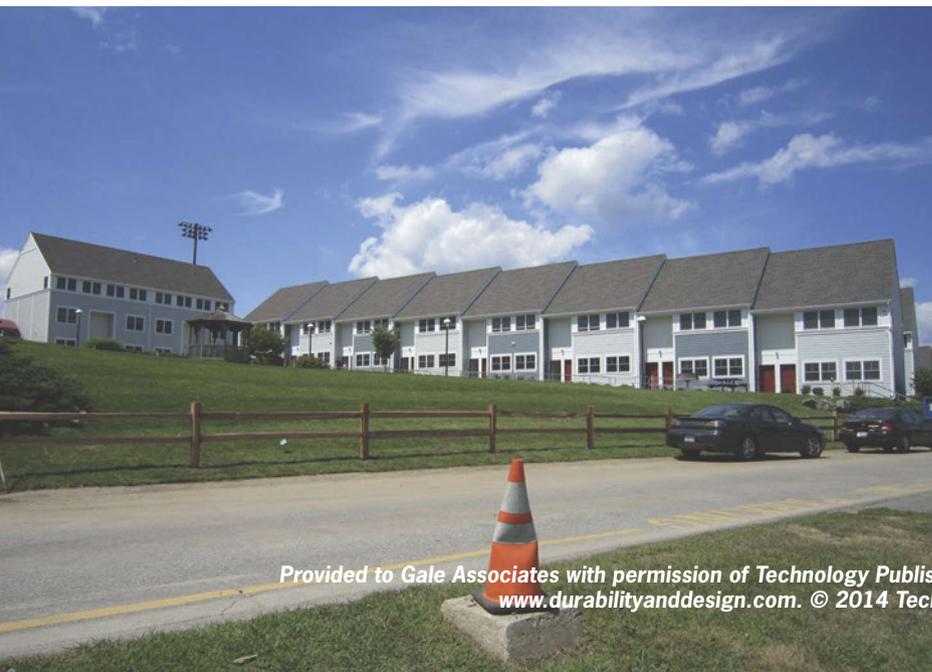
*Bottom right: These townhouse-style dorms at a New England university were slated for energy-efficiency upgrades and an update in appearance.*

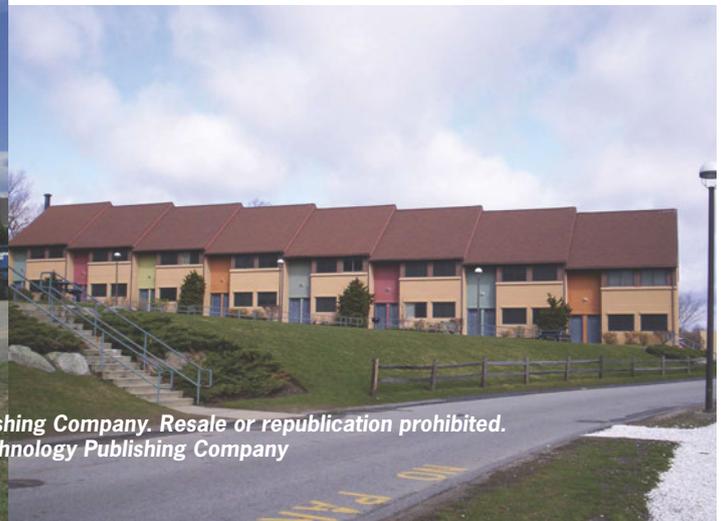
*Bottom left: Following their energy-efficiency retrofit, the dorms sport a more traditional New England fiber cement clapboard and shingle palette.*  
All photos courtesy of Gale Associates.

The university decided to replace the modernist, monolithic EIFS style with a more traditional New England aesthetic. Officials chose a fiber cement clapboard and shingle palette.

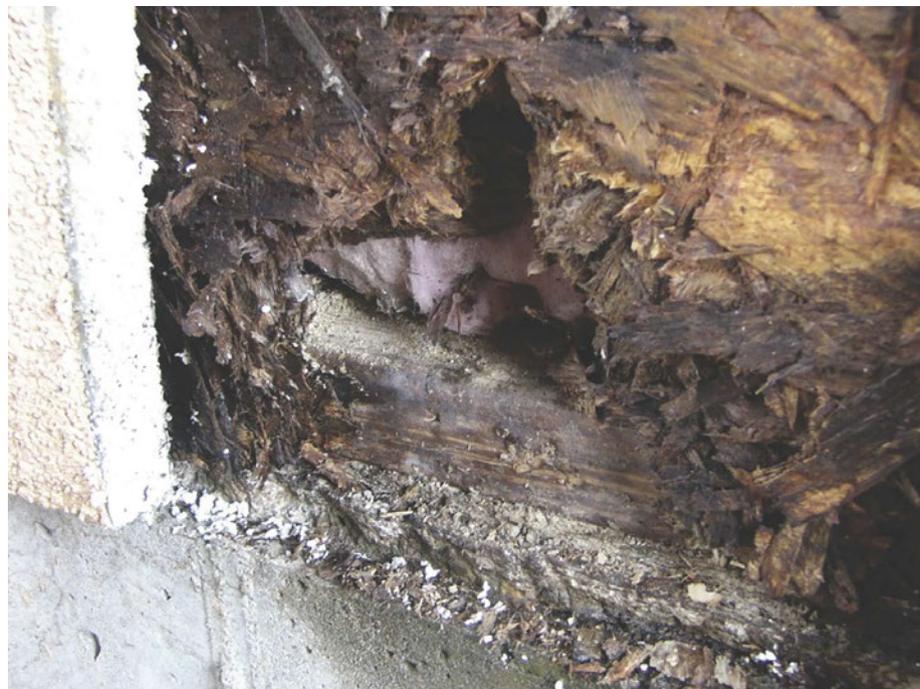
Test cuts reveal unadhered EIFS and deteriorated sheathing and sill plates.

An infrared thermography (IR) scan and destructive test cuts revealed failed EIFS panels had let moisture migrate into the OSB sheathing and fiberglass batt insulation. This moisture infiltration caused deterioration of the OSB sheathing, saturated

the fiberglass and contributed to mold growth within the wood stud wall.

The replacement wall system consisted of new plywood sheathing, blown-in cellulose insulation, a self-adhered vapor permeable air barrier, one-inch (2.5-centimeter) rigid insulation and fiber cement siding installed to wood furring. The original aluminum slider windows were replaced with ENERGY STAR-rated, aluminum-clad, double-hung wood windows to match the de-

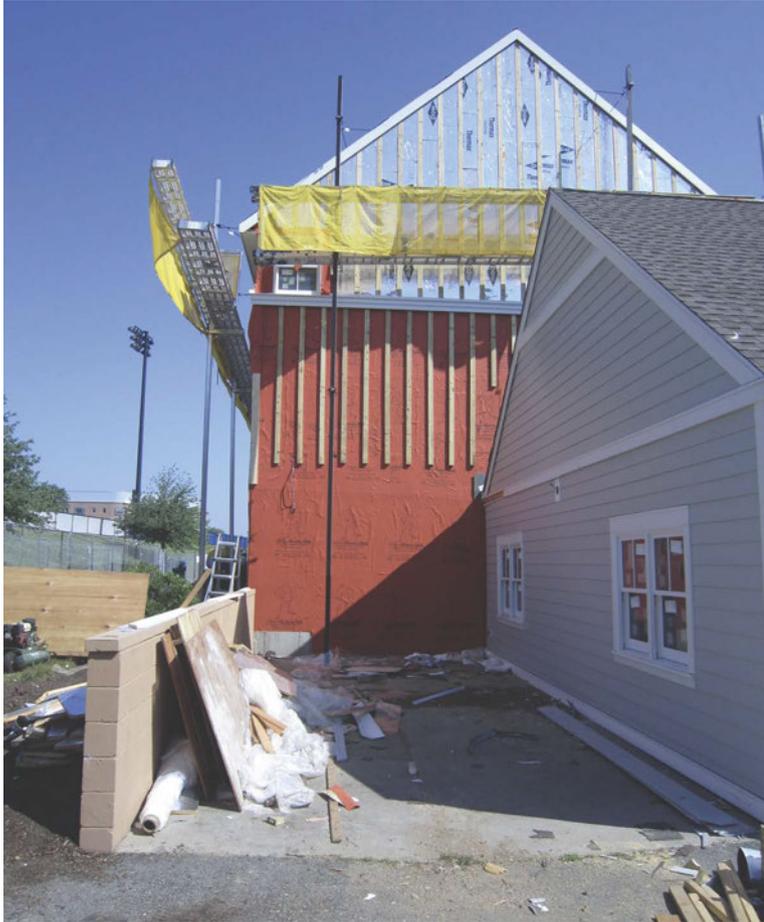
A retrofitted wall complete with ENERGY STAR-rated, aluminum-clad, double-hung wood windows stands next to an under-construction wall showing the orange air barrier and blue non-structural rigid insulation.

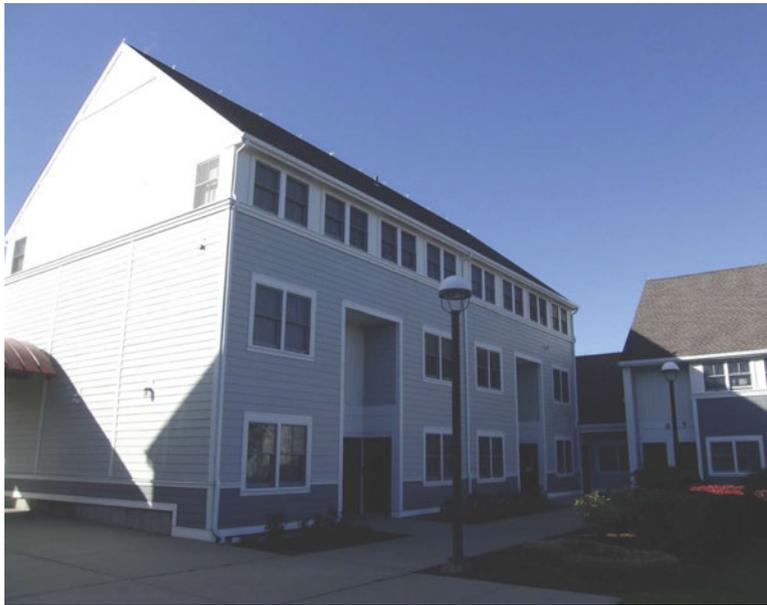
Air infiltration at the renovated first- and second- floor units, N1 and N2, was significantly reduced and was only apparent during testing.

Unit	Volume/sq. ft. (sq. m.)	ACH50 Air exchanges per hour at 50 Pa (ACH50)
E1	4,890 (454)	5.85
N1	4,890 (454)	4.12
E2	5,330 (495)	9.67
N2	5,330 (495)	9.16

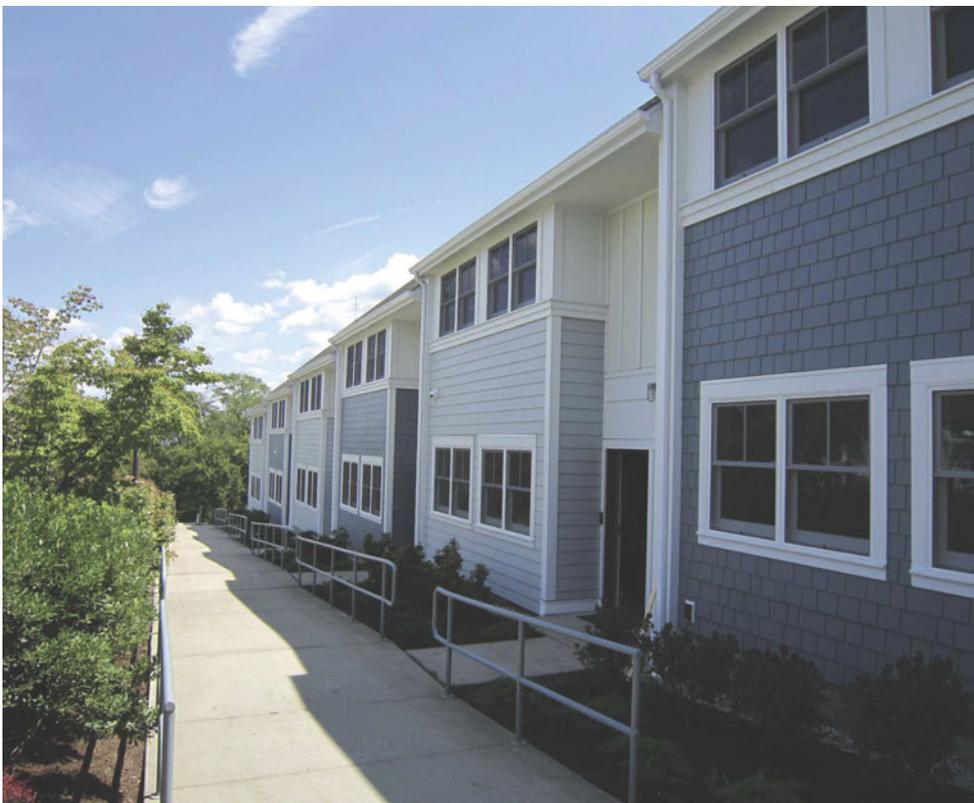
*New thermally efficient exterior walls, windows and doors also greatly improved the water-tightness of the building enclosure, reducing the potential for moisture-related issues.*

University officials expect further energy savings when the attic and inter-unit leaks are addressed. New thermally efficient exterior walls, windows and doors also greatly improved the water-tightness of the building enclosure, reducing the potential for moisture-related issues and providing a long-lasting assembly.

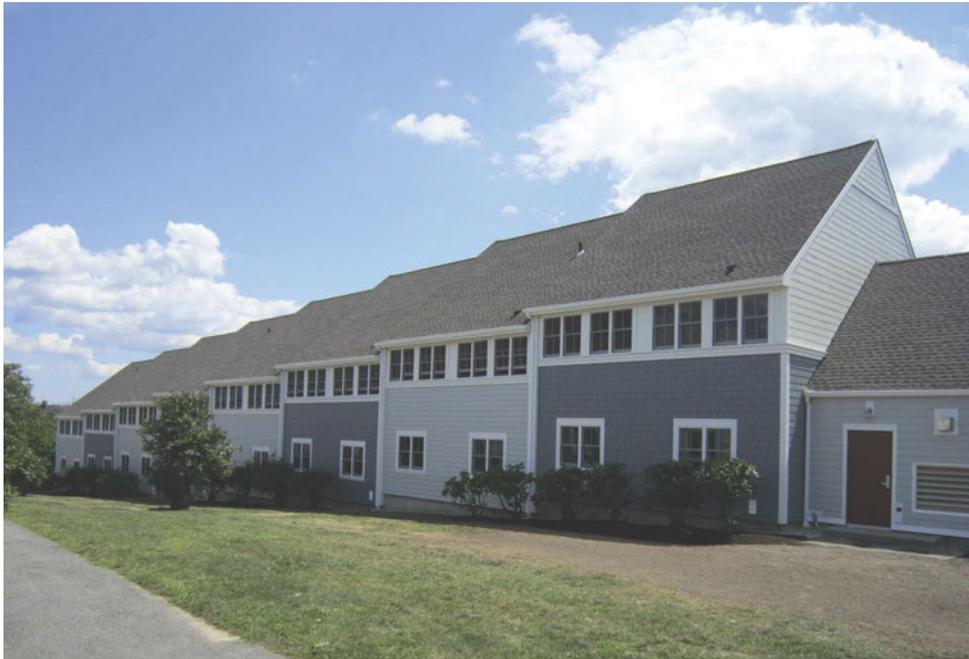
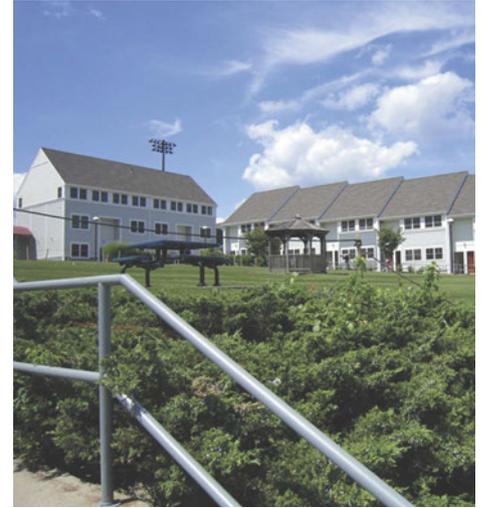
The project team used a blower door test to compare air-infiltration rates at a pair of two-story dormitories, one unchanged and the other newly renovated, in summer 2013. Blower door test ASTM E779-10 Standard Test Method for Determining Air Leakage Rate by Fan Pressurization measured the airflow in cubic feet per minute through a single fan to create a 50-pascal (Pa) change in building pressure, or CFM50.

(Above and right) Blower door testing confirmed that the building envelope upgrade reduced energy costs and improved occupant comfort in these dormitories at a New England University.
